Technical Report CERC-96-8
September 1996

Periodic Inspection of Burns Harbor North Breakwater, Indiana

Report 1 Base Conditions

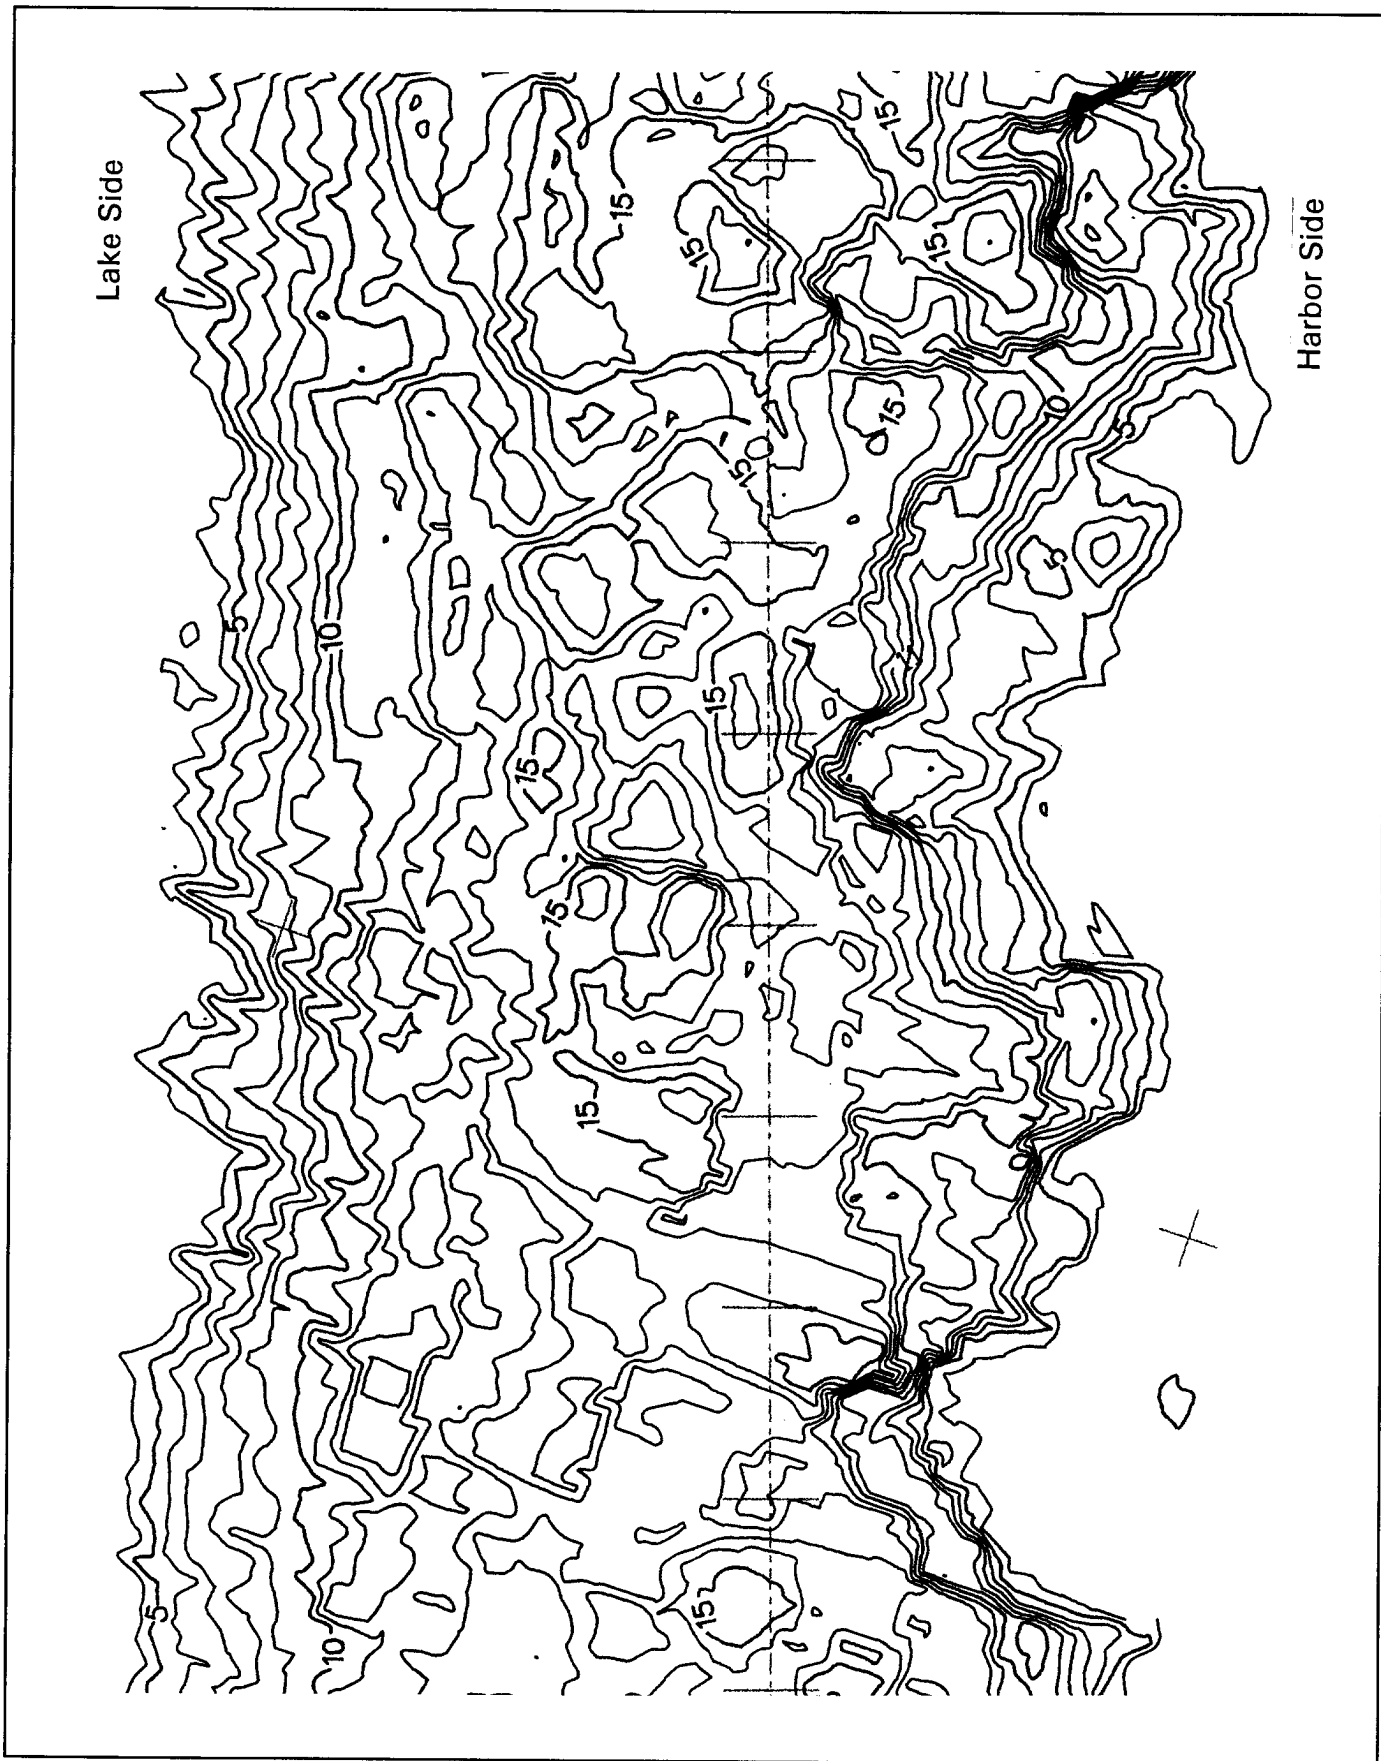
Figure A22. Topography of Burns Harbor North Breakwater, sta 18+05-18+90

This appendix presents contour maps of the Burns Harbor North Breakwater. Topography was developed using the digital terrain model (DTM) as stated in the main text of this report. The breakwater topography is shown on a 0.3-m (1.0-ft) contour interval. Elevations shown are in feet referred to low water datum (lwd). To convert them to meters, multiply by 0.3048. Station numbering on the contour maps is from east to west (right to left). The scale of the maps is 25.4 mm = 3.05 m (1 in = 10 ft).

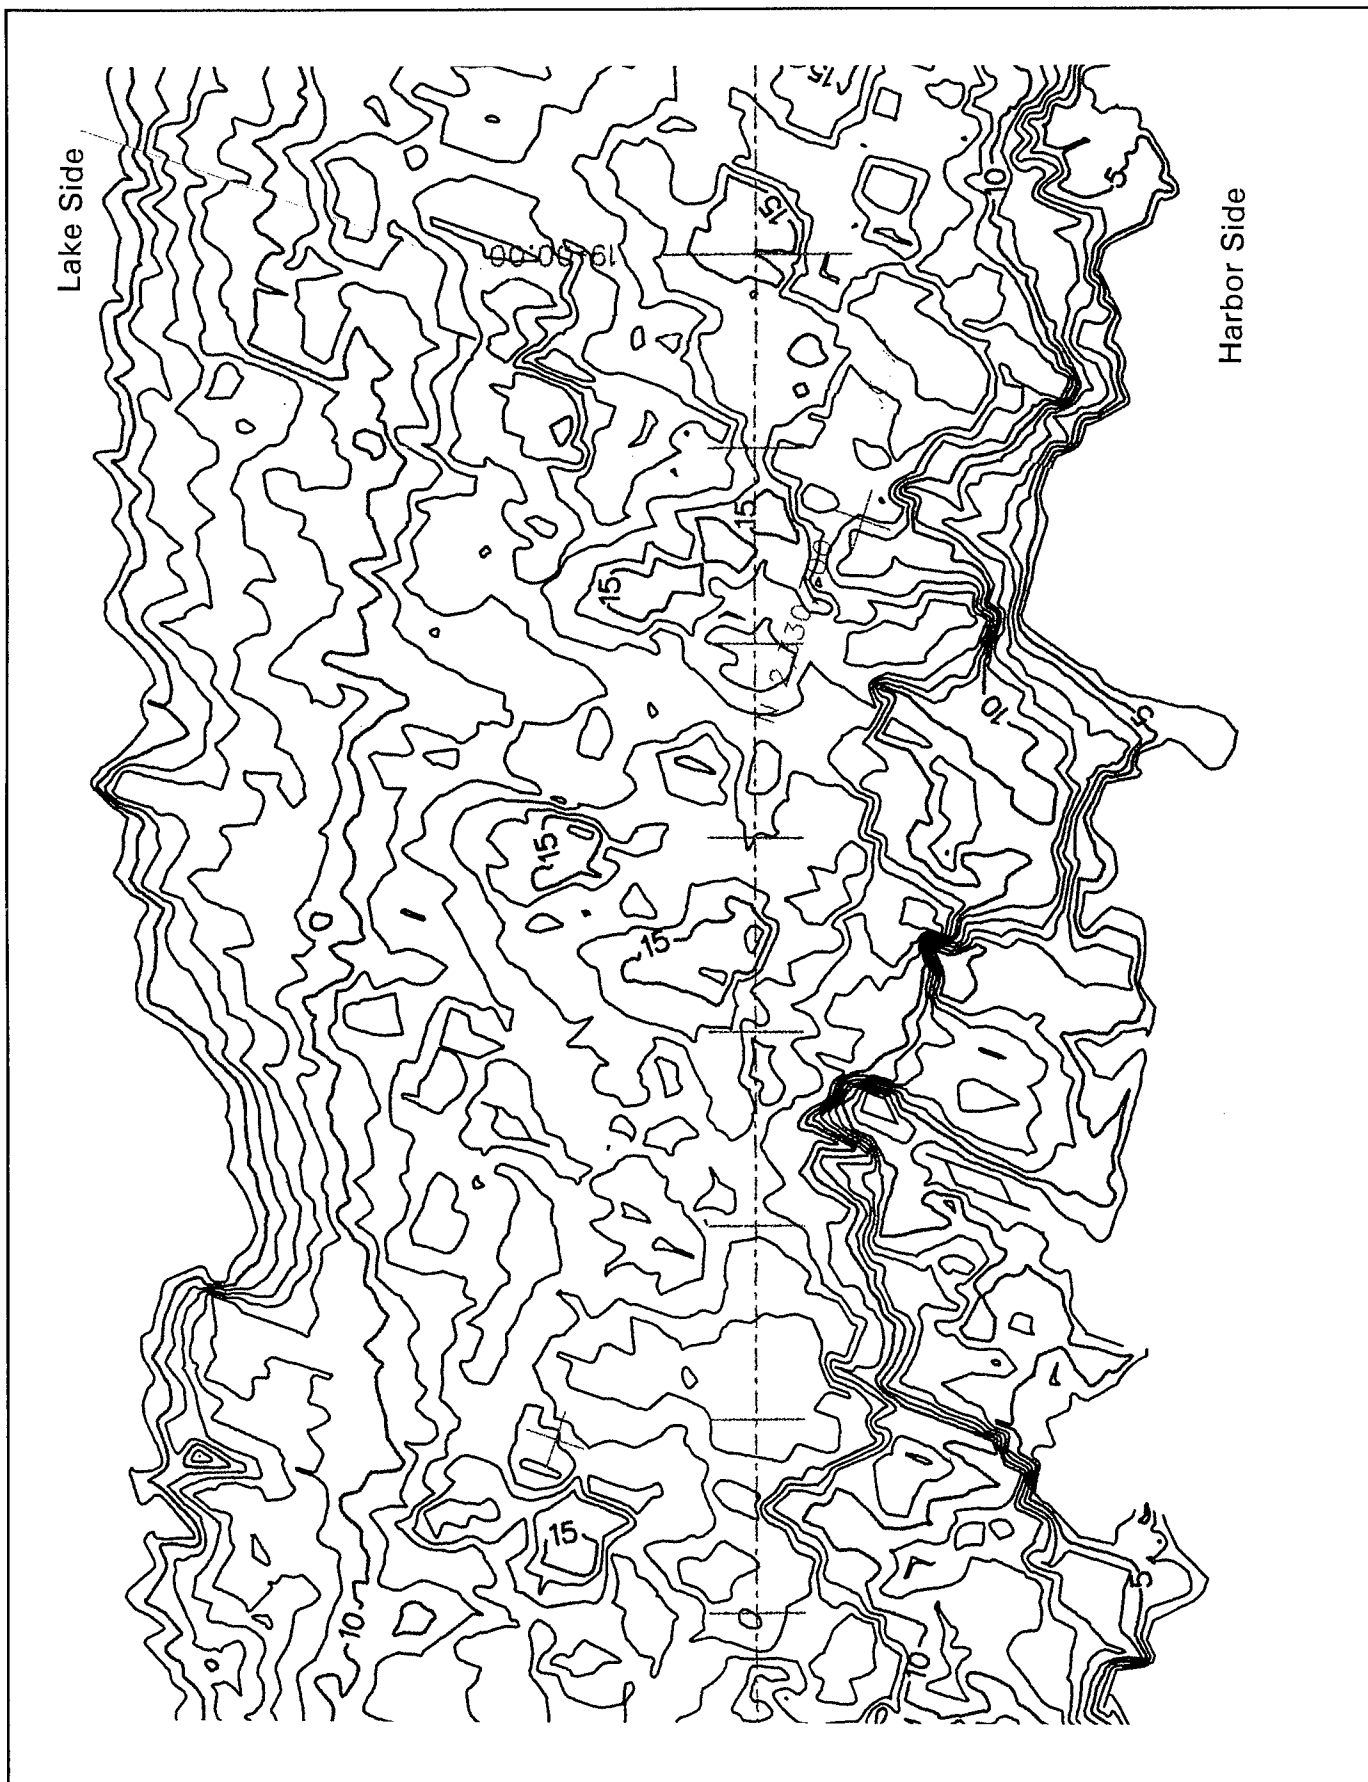
Figure A23. Topography of Burns Harbor North Breakwater, sta 18+90-19+76

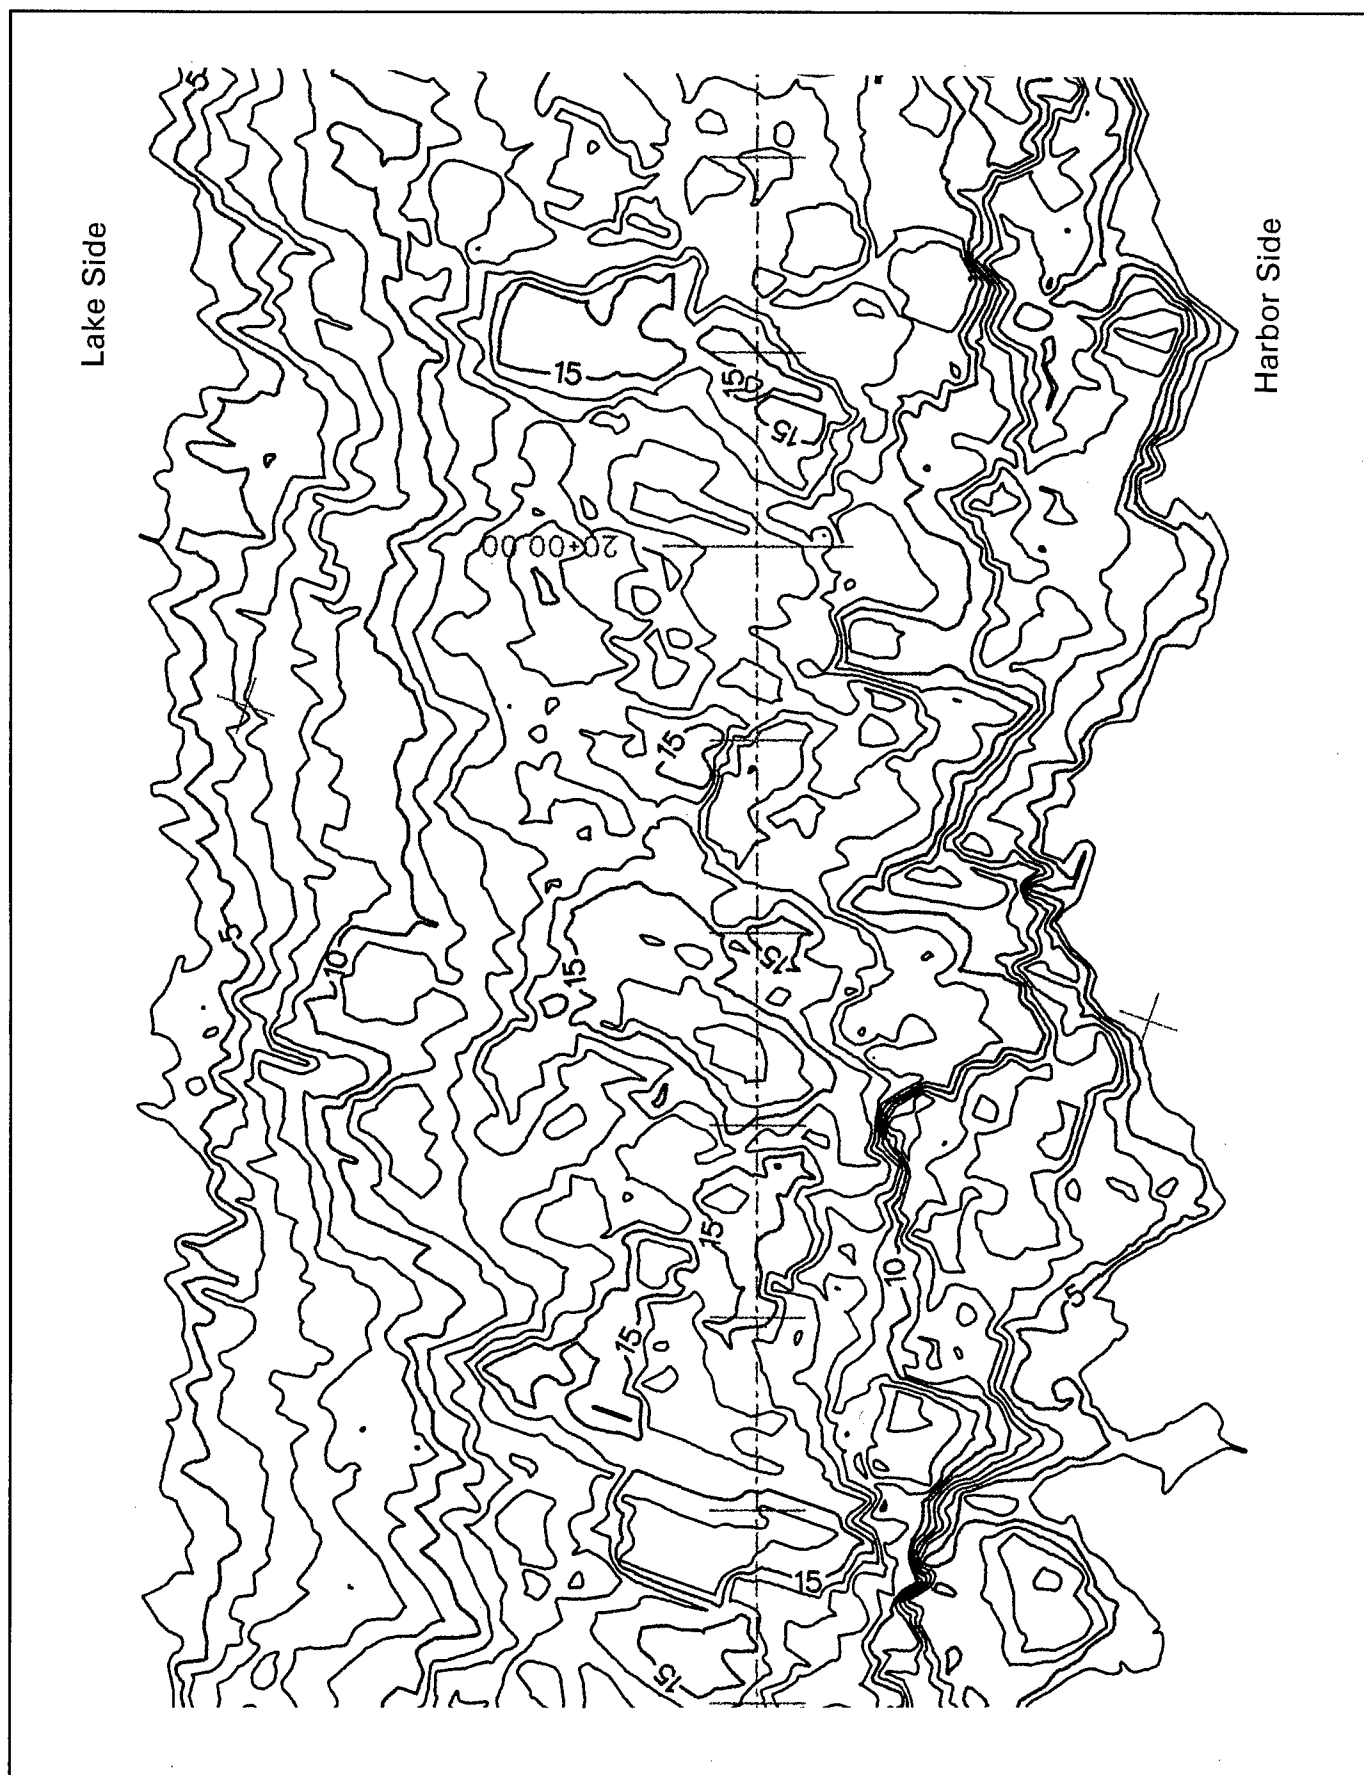
Figure A24. Topography of Burns Harbor North Breakwater, sta 19+76-20+60

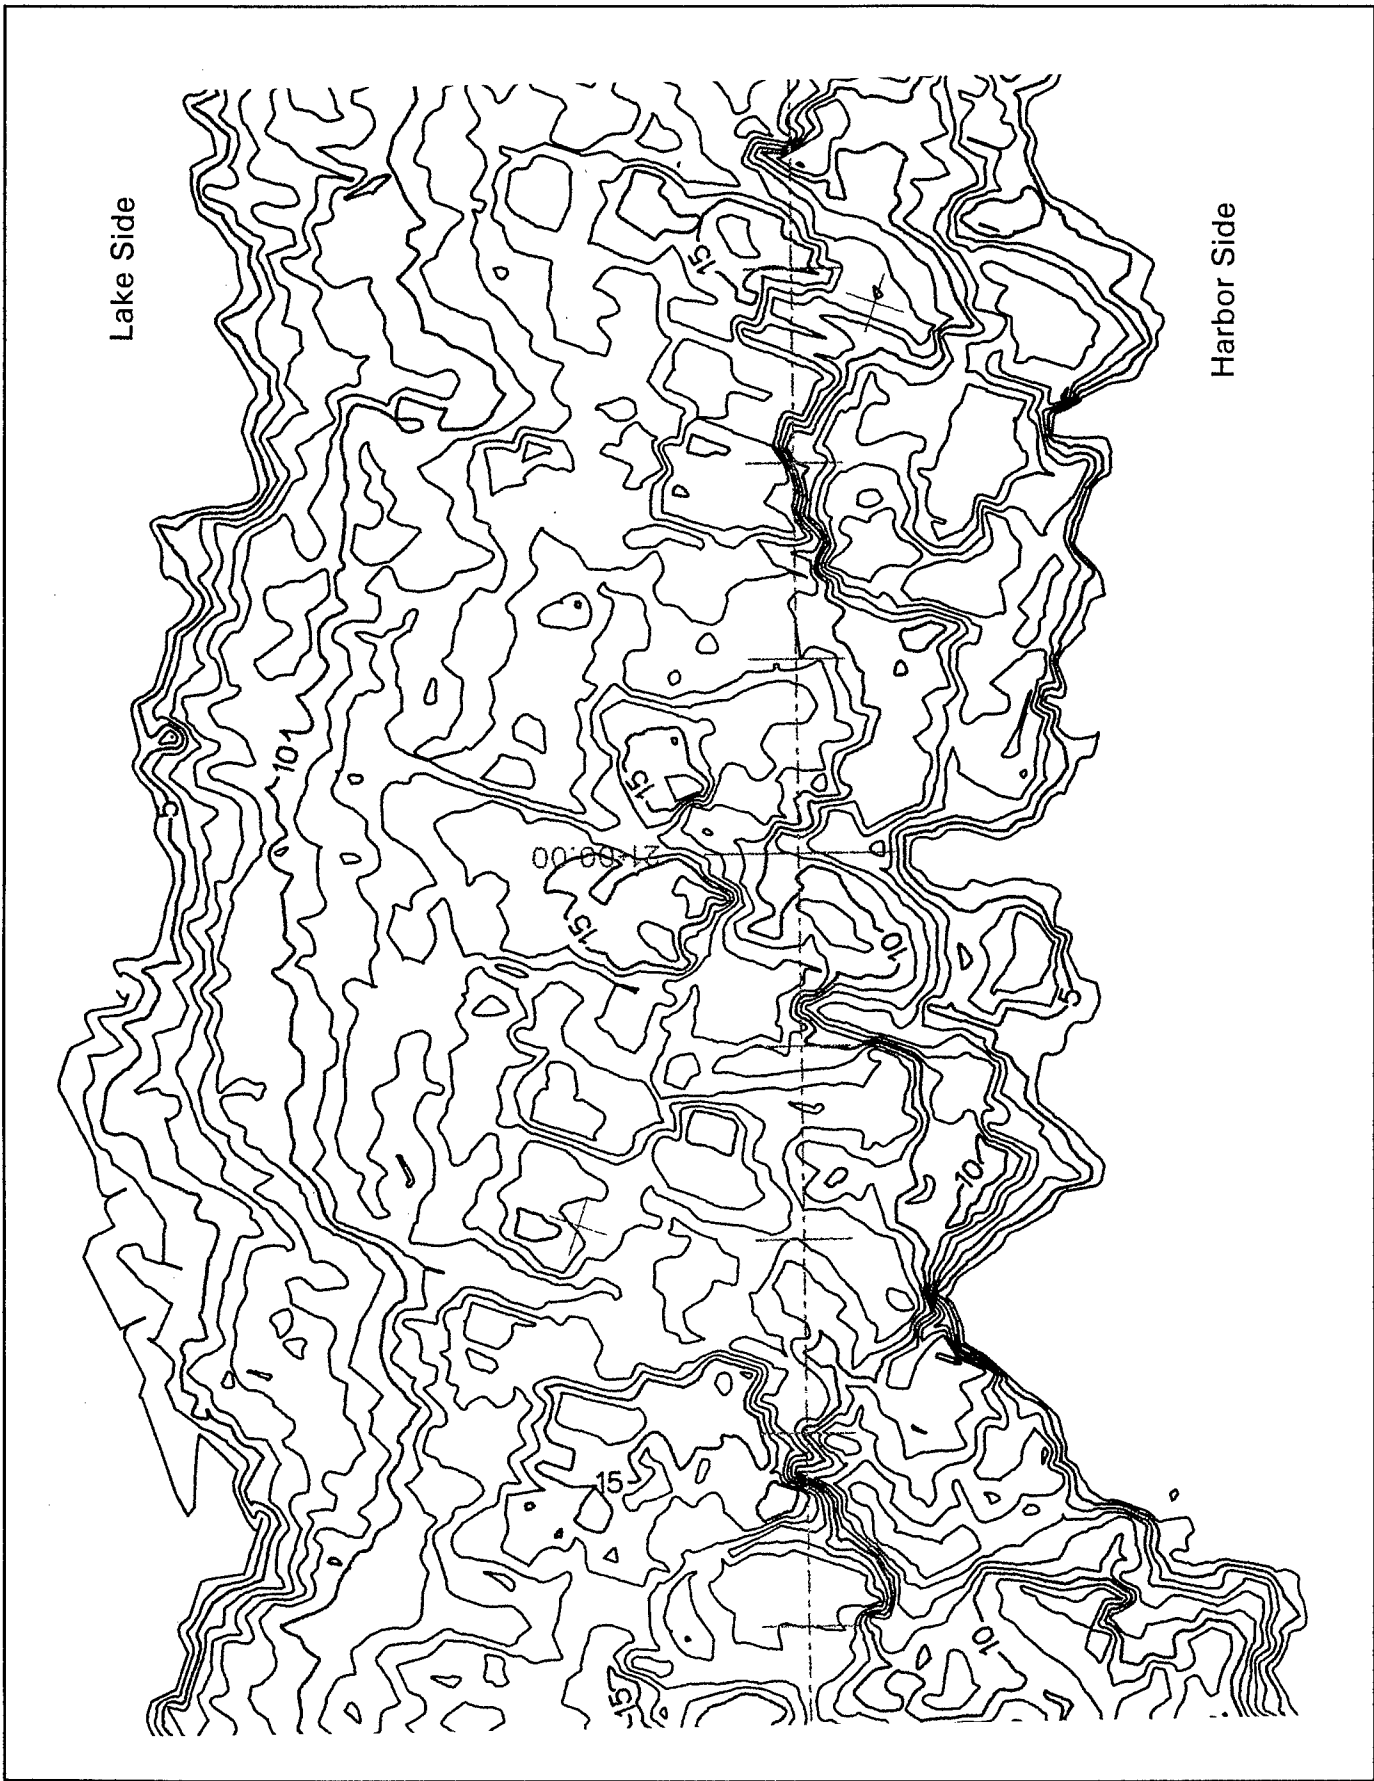
Figure A25. Topography of Burns Harbor North Breakwater, sta 20+60-21+45

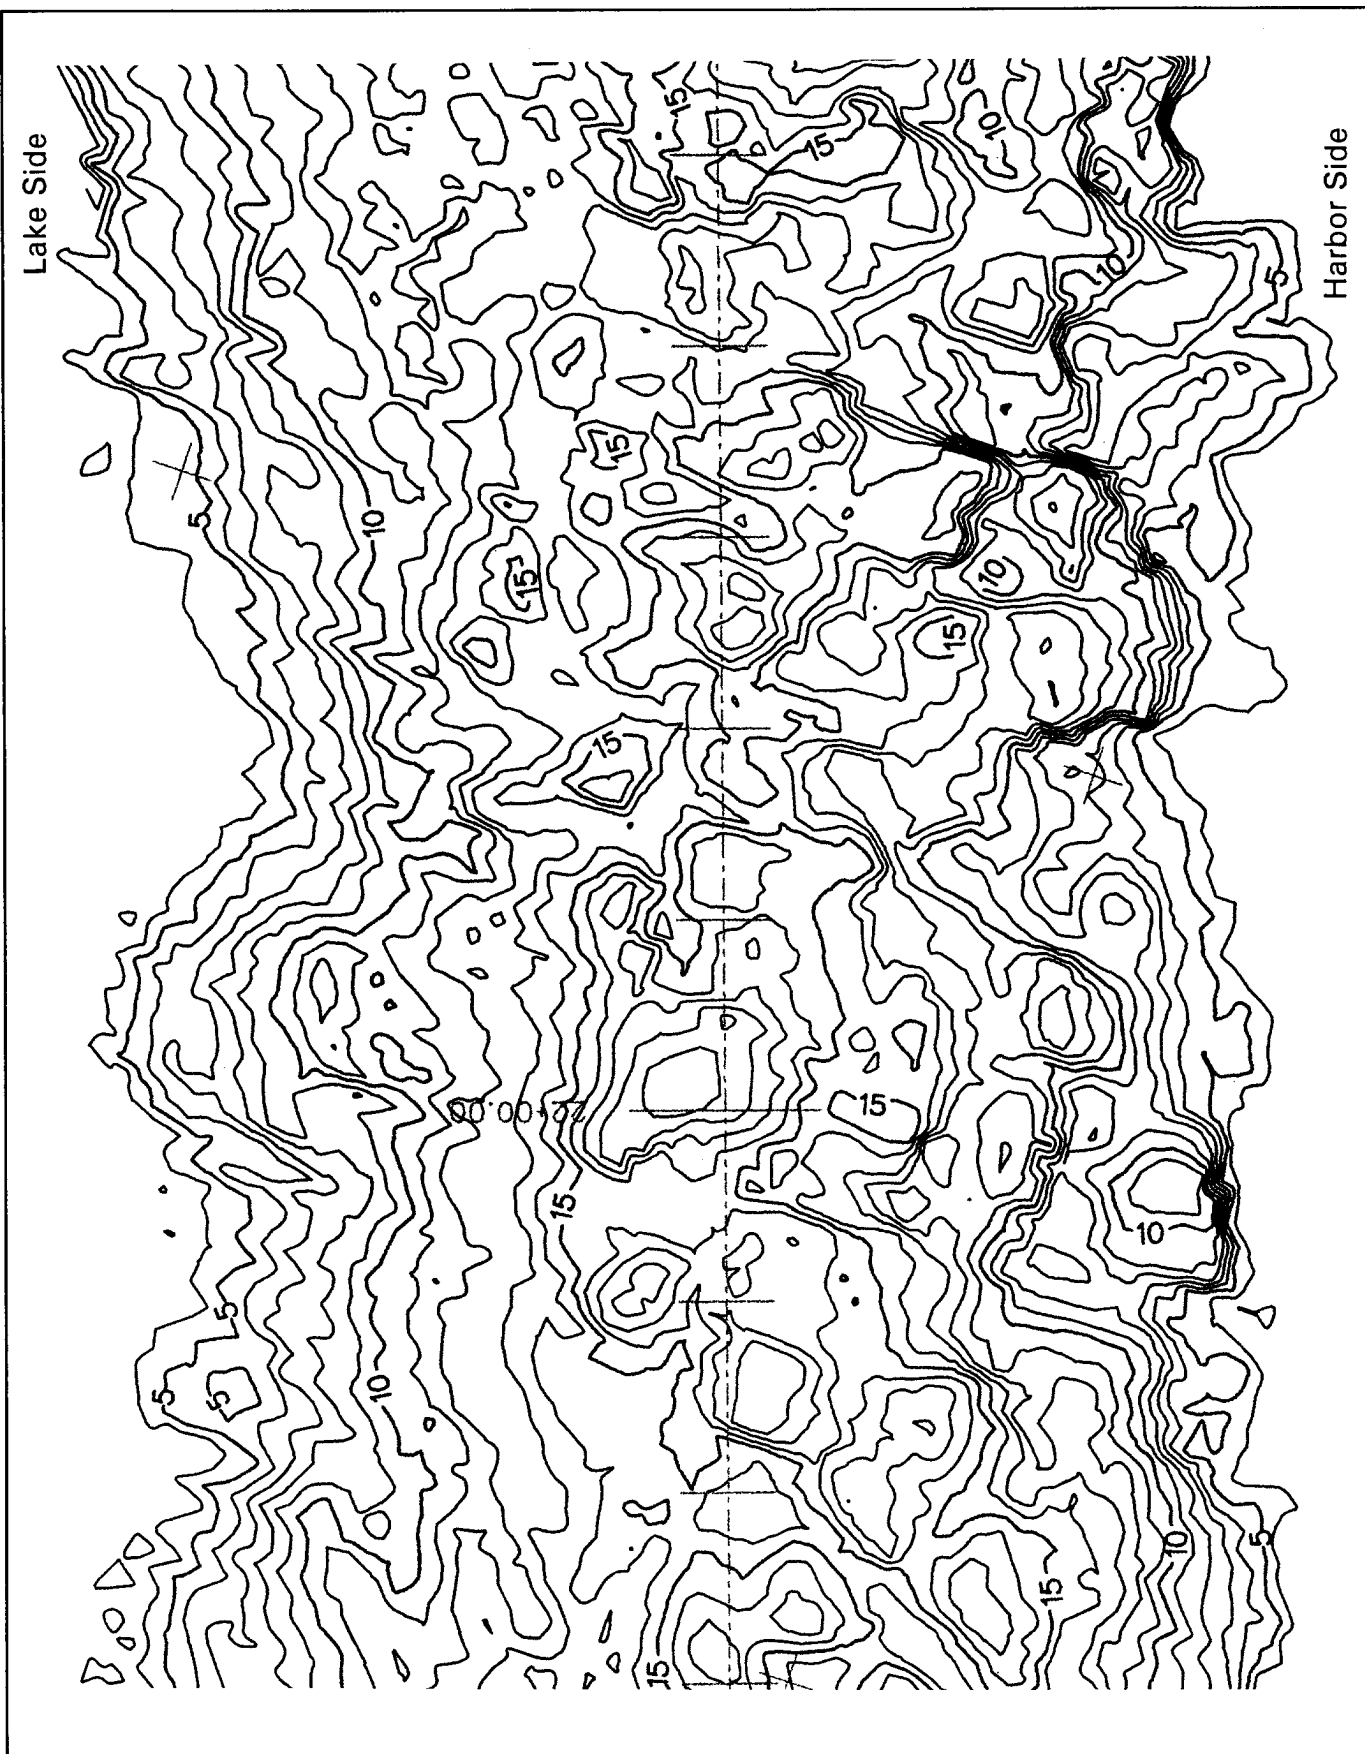
Figure A26. Topography of Burns Harbor North Breakwater, sta 21+45-22+30

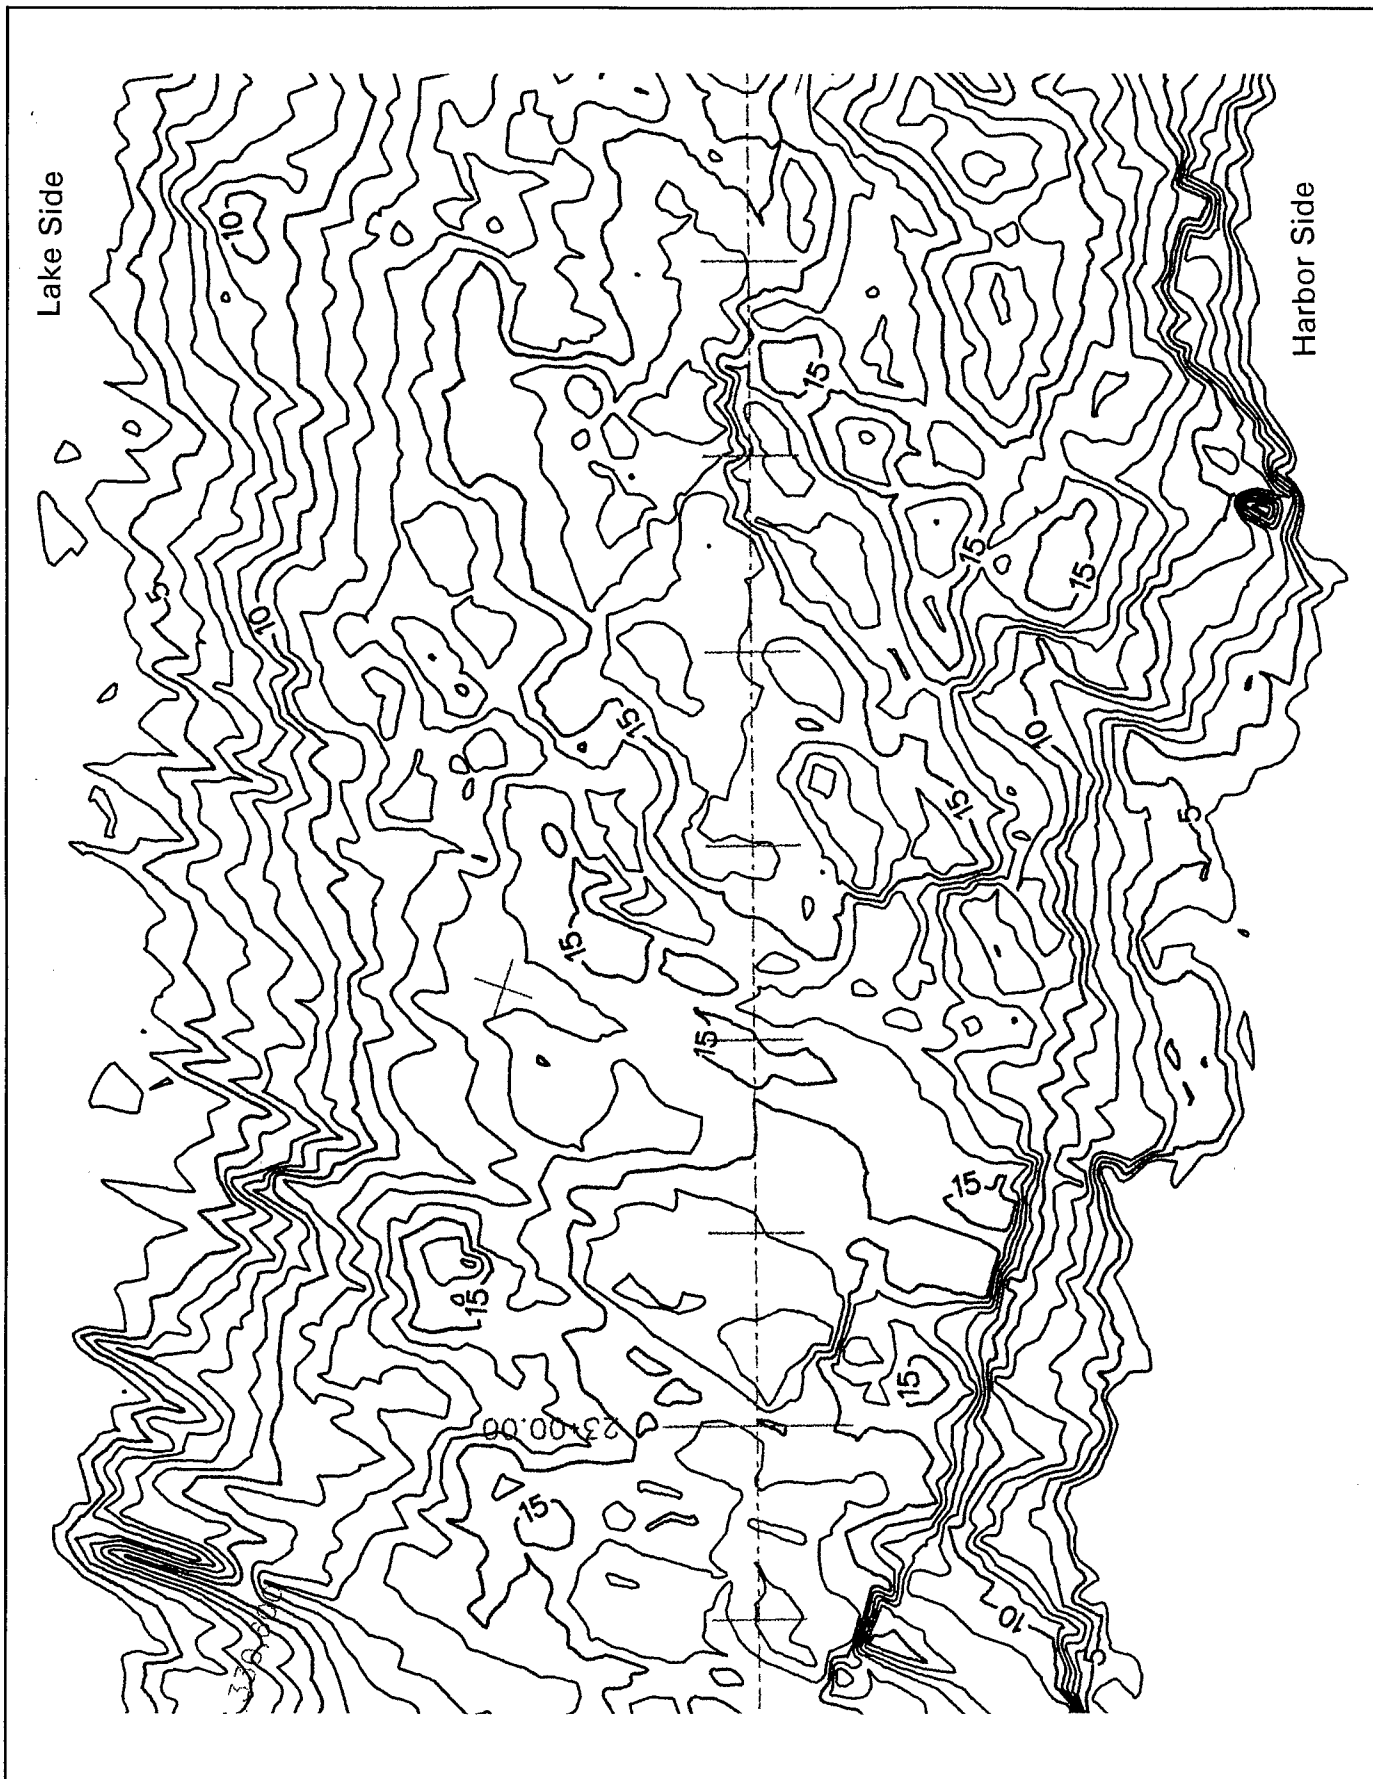
Figure A27. Topography of Burns Harbor North Breakwater, sta 22+30-23+15

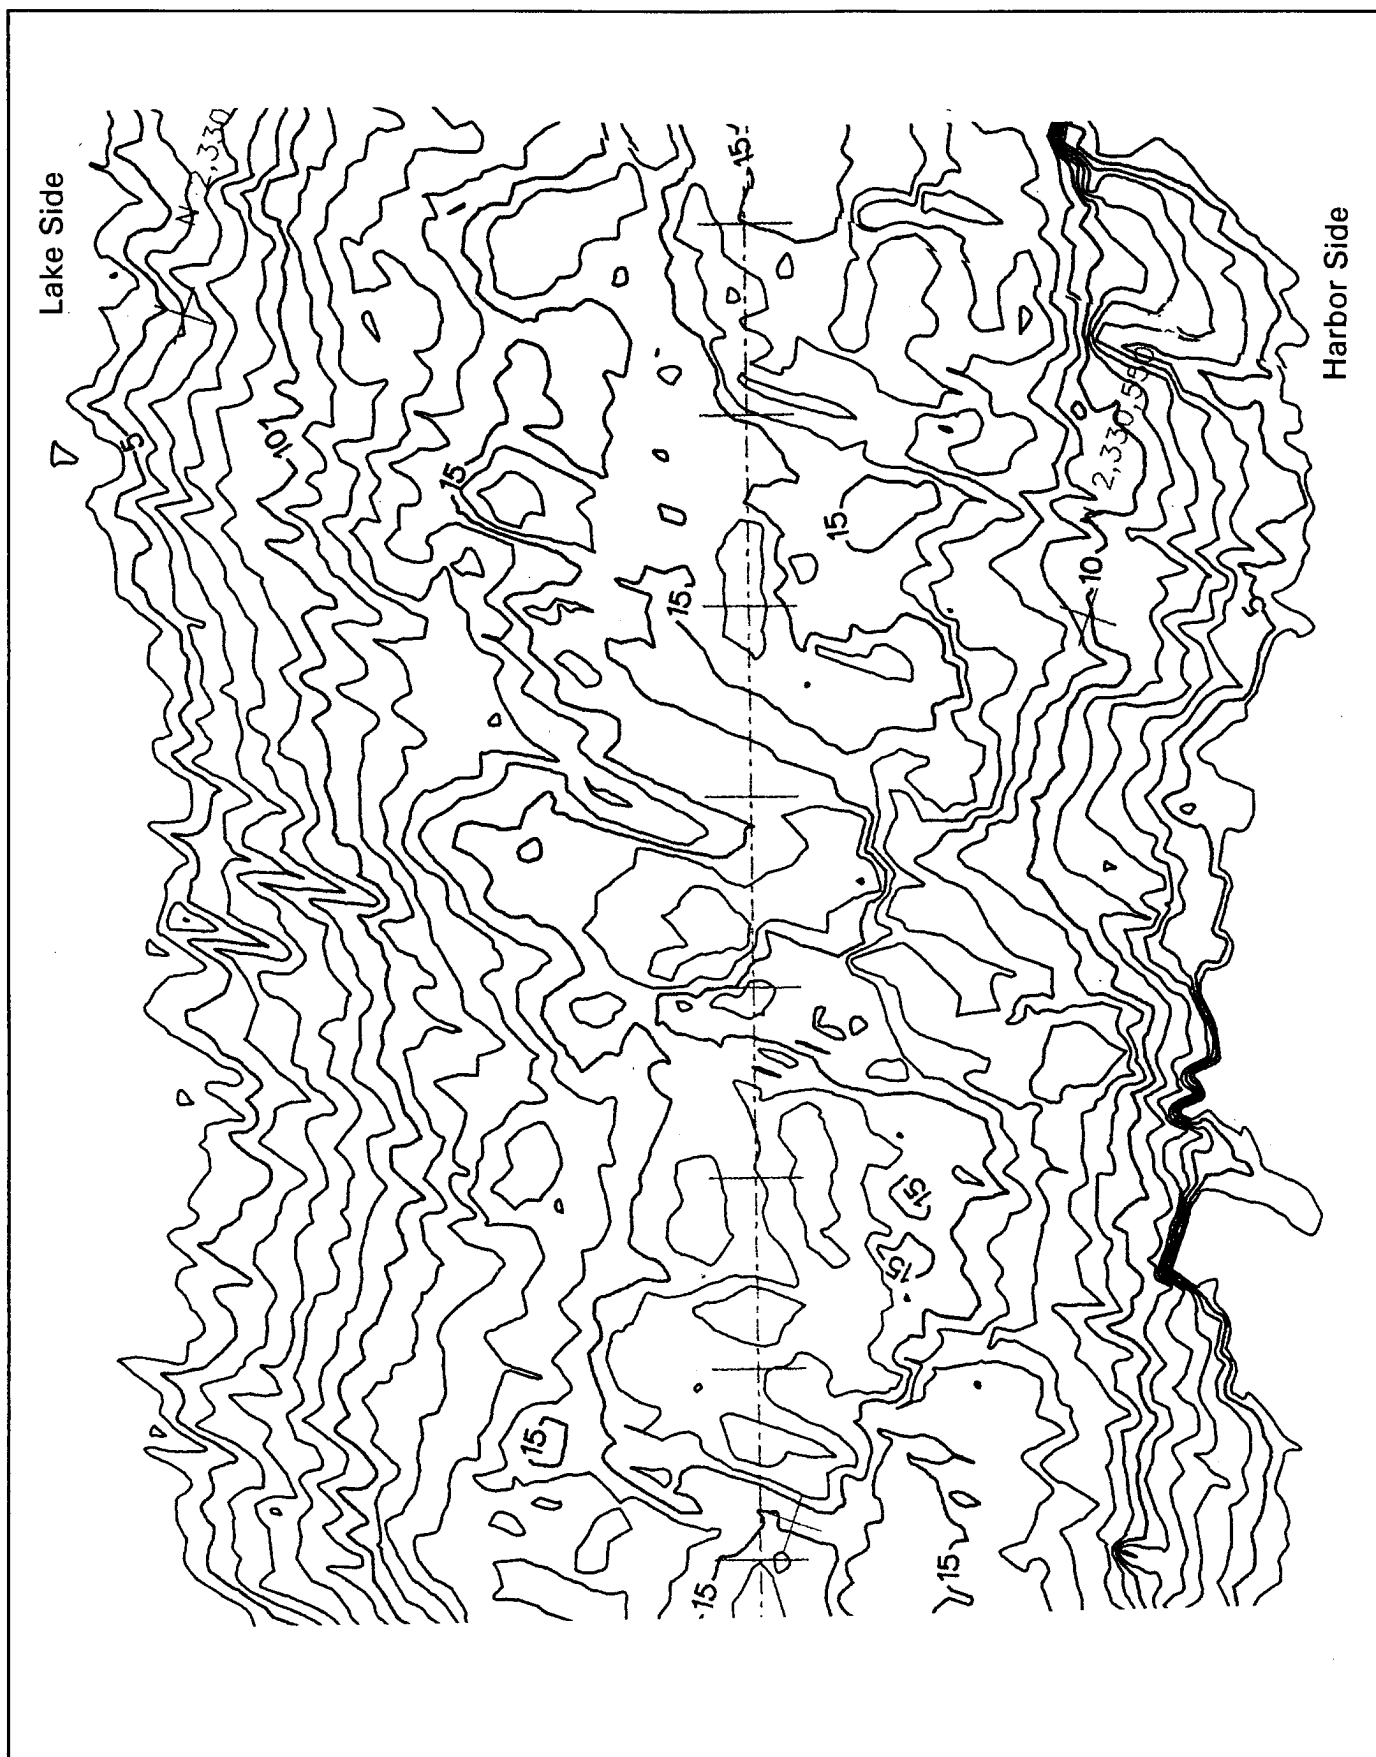
Figure A28. Topography of Burns Harbor North Breakwater, sta 23+15-23+93

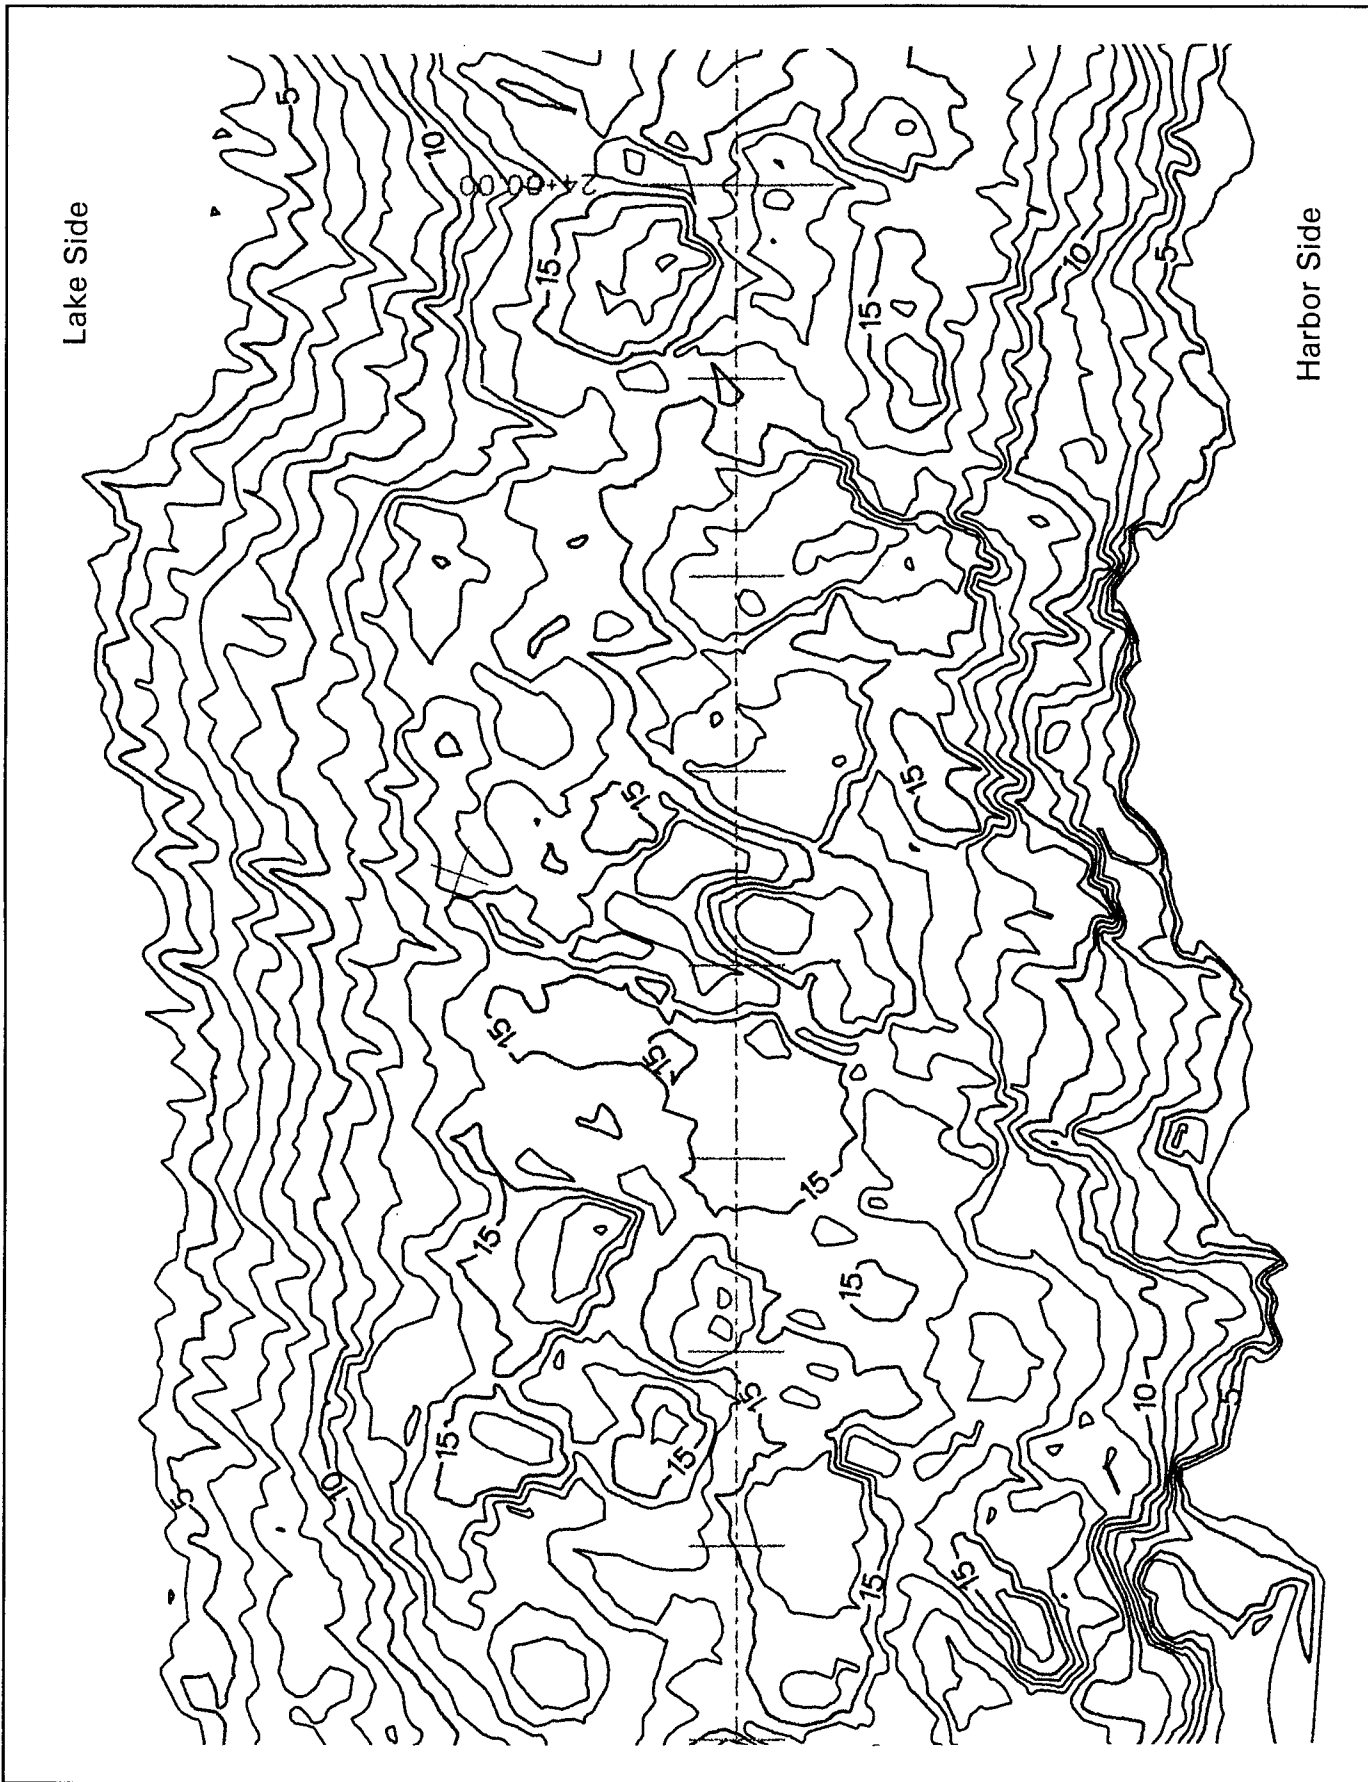
Figure A29. Topography of Burns Harbor North Breakwater, sta 23+93-24+80

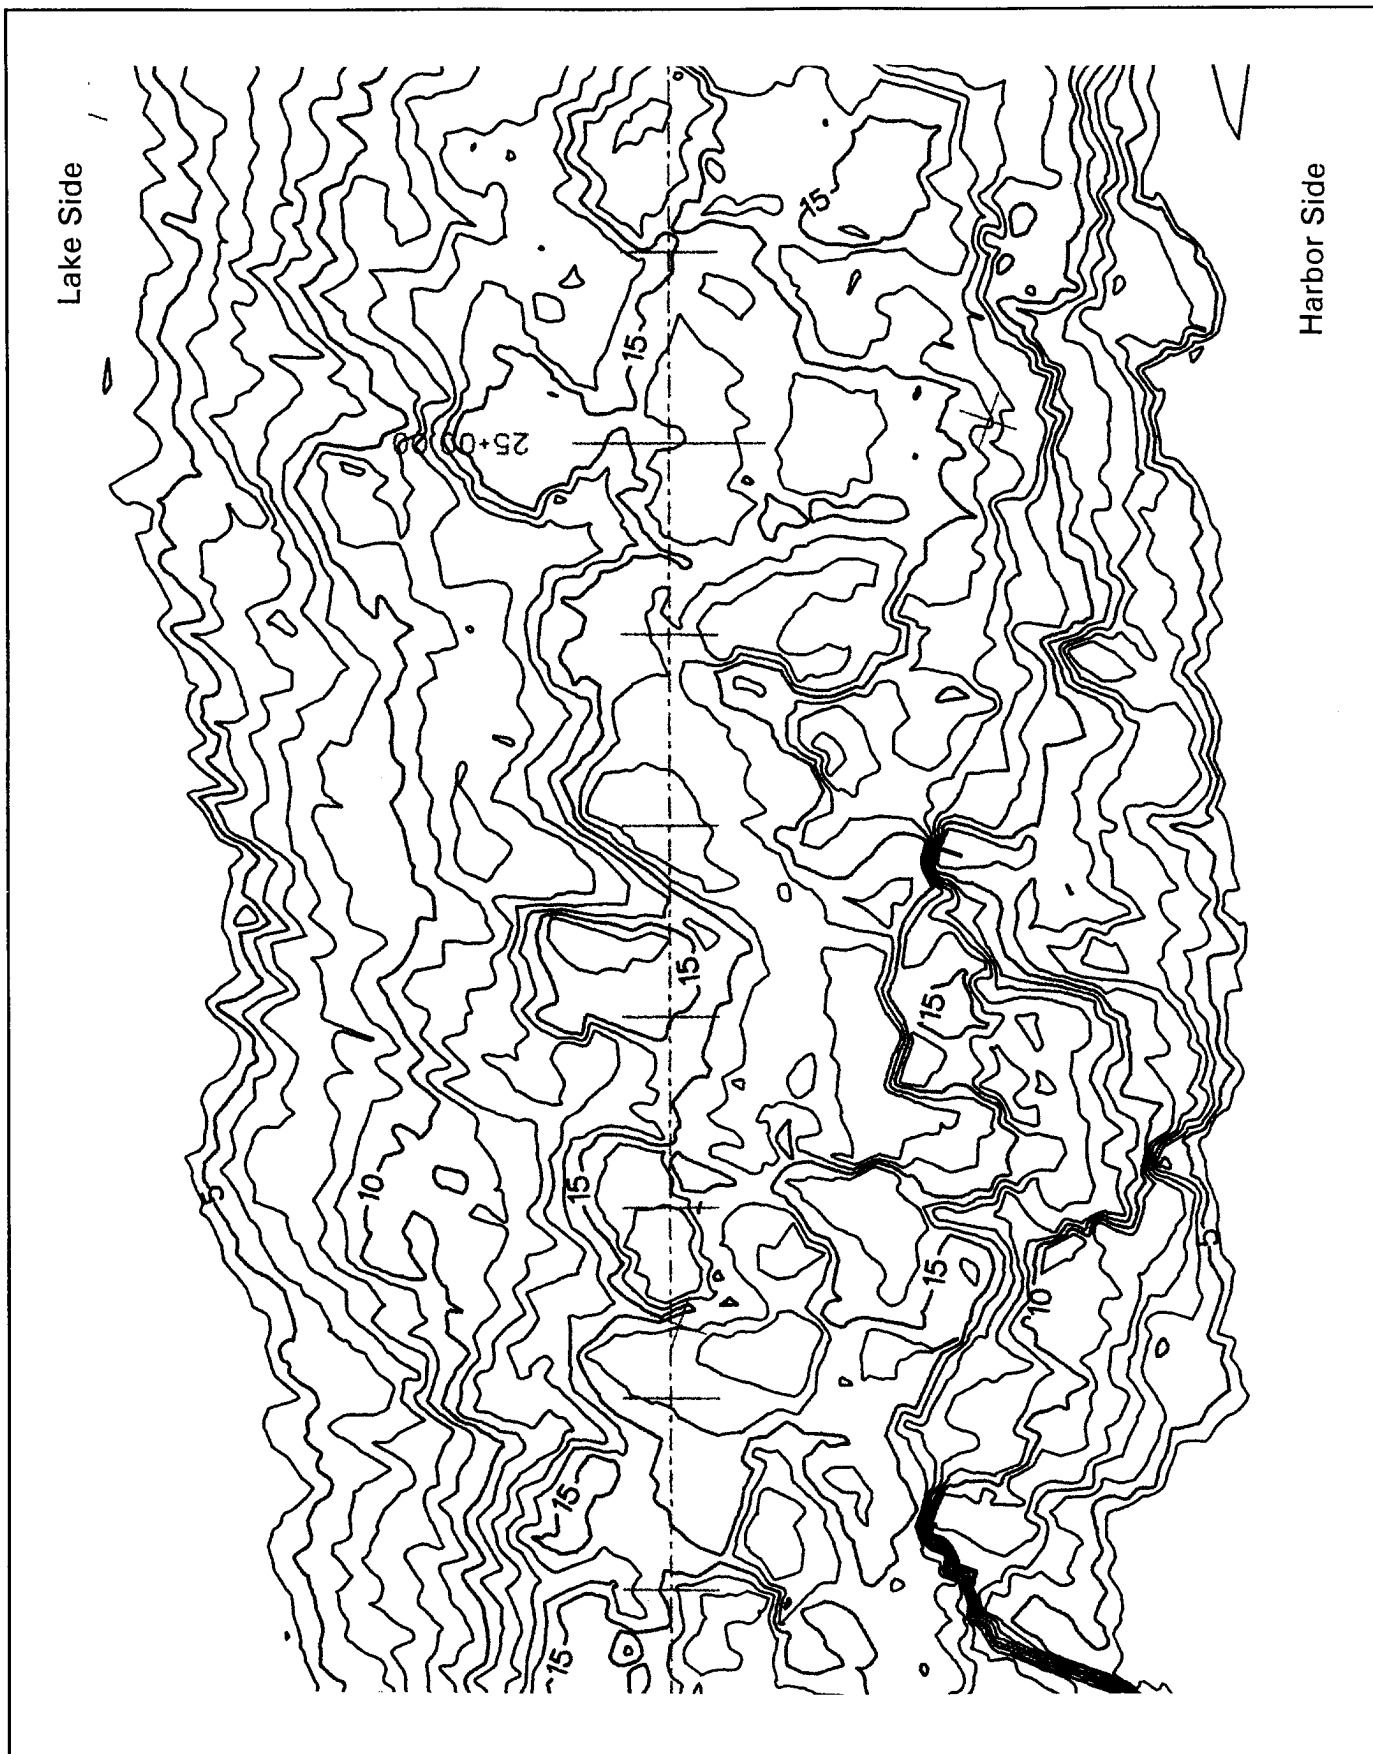
Figure A30. Topography of Burns Harbor North Breakwater, sta 24+80-25+65
